Summary Action Report

Structure ID: D-0007

<u>Structure Name:</u>	Sideroad 3 Bridge	Bridge Condition Index (BCI): 34
<u>Road Name:</u>	Sideroad 3	
<u>Location:</u>	Lot 3/4 Concession 11, Derby	<u>Inspection Date:</u> May 31, 2024
<u>Structure Type:</u>	Concrete Rigid Frame	<u>Inspected By:</u> Jesse Borges, P.Eng.
<u>No. of Spans:</u>	Single Span	<u>Spans Lengths:</u> 6.3m
<u>Road Width:</u>	5.5m	<u>Overall Structure Width:</u> 6.3m
<u>Year of Construction:</u>	1925	<u>Current Load Limit:</u> Closed

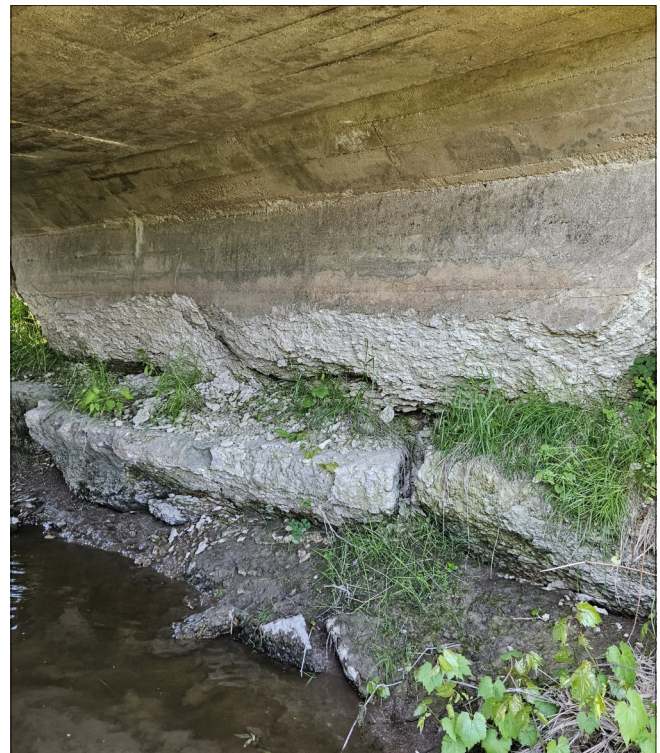
18.9
			Perform. Deficiencies
			None
Comments: Severe spalling on bottom 0.6m of west abutment for the entire length, up to 0.5m deep. Extreme section loss noted at the northwest corner. East abutment has severe spalling at the north corner. Wide cracking is noted on the north side of the walls on both the east and west side.			
Recommended Work:		Maintenance Needs:	None
<input type="checkbox"/> Rehab <input checked="" type="checkbox"/> Replace <input type="checkbox"/> Urgent <input checked="" type="checkbox"/> 1-5 years <input type="checkbox"/> 6-10 years <input type="checkbox"/> None		<input type="checkbox"/> Urgent <input type="checkbox"/> 1 year <input type="checkbox"/> 2 year	
Structure to be permanent removed or replaced.

Photo 4 - View of West Footing and Abutment Wall.

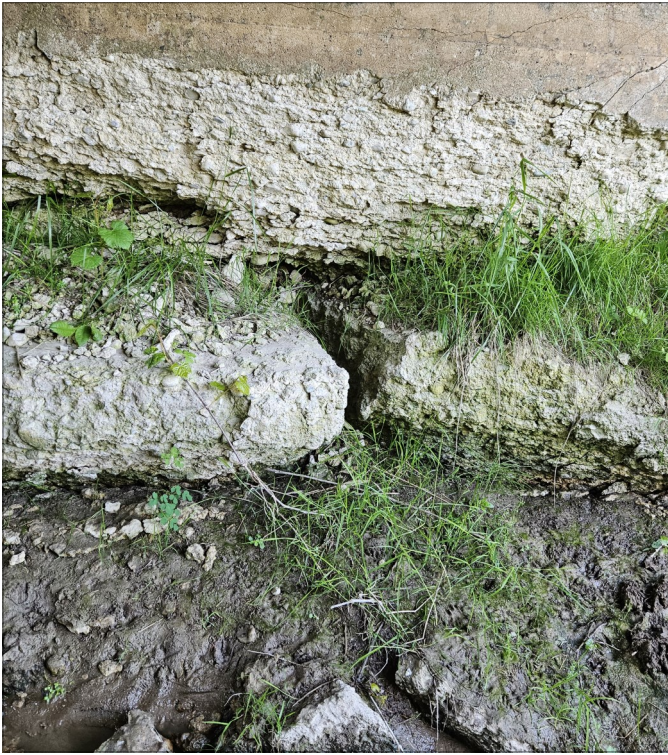
Photo 5 - View of Wide Cracking in West Footing.

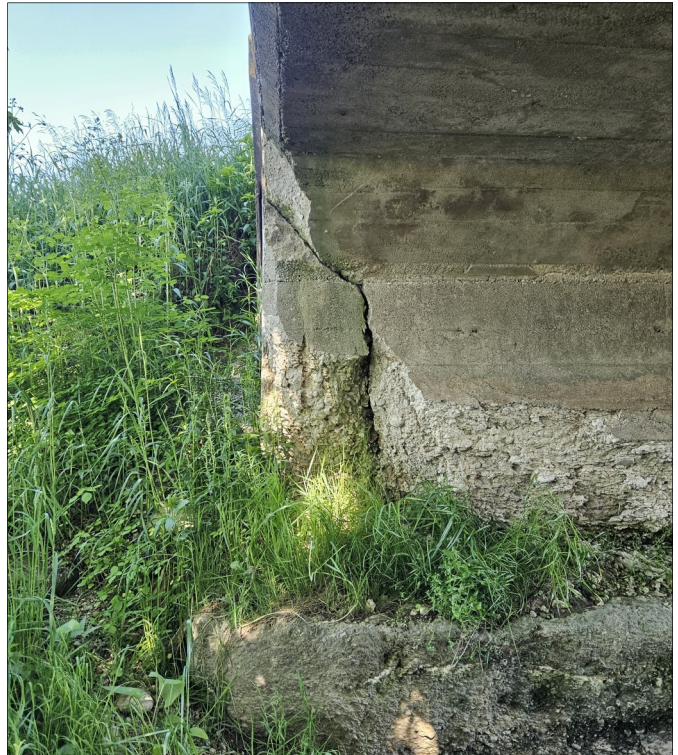
5.1
			5
			Perform. Deficiencies
			02
Comments: Severe shear cracking noted at the wingwall/abutment wall interface at all 4 corners of the structure. All of the wingwalls are rotating away from the structure.			
Recommended Work:		Maintenance Needs:	None
<input type="checkbox"/> Rehab <input checked="" type="checkbox"/> Replace <input type="checkbox"/> Urgent <input checked="" type="checkbox"/> 1-5 years <input type="checkbox"/> 6-10 years <input type="checkbox"/> None		<input type="checkbox"/> Urgent <input type="checkbox"/> 1 year <input type="checkbox"/> 2 year	
Structure to be permanent removed or replaced.

Photo 6 - View of Wide Cracking at Abutment / Wingwall Interface.

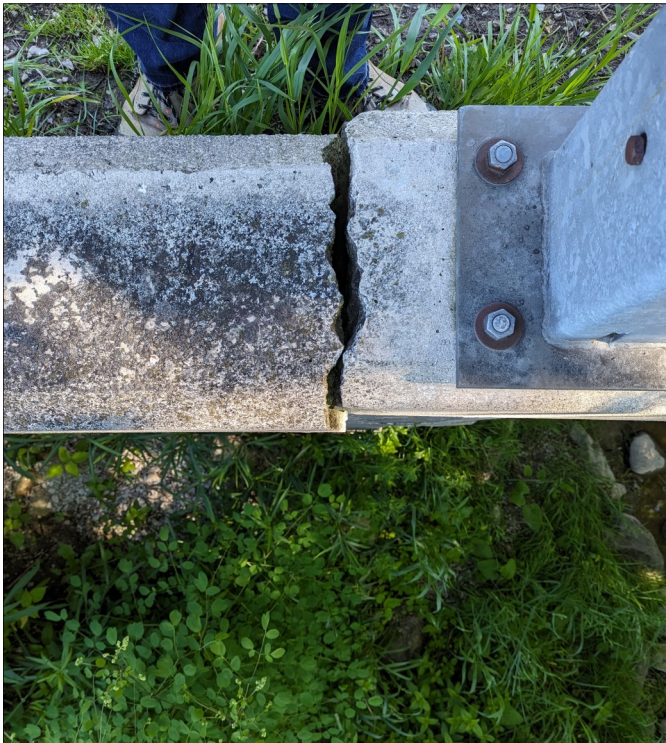
Photo 7 - View of Wide Crack in Curb and Outward Rotation of Wingwall (typ.).

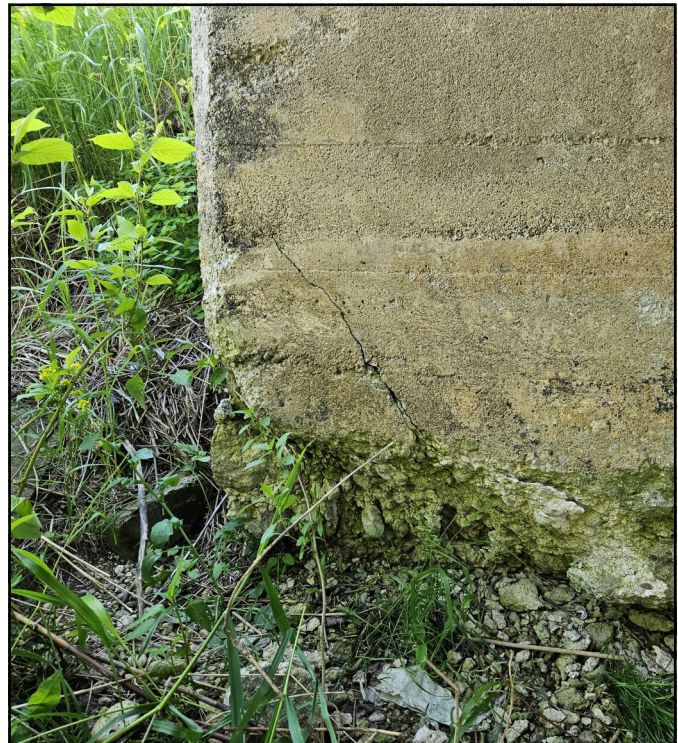
Photo 8 - View of Spalling on East Abutment.

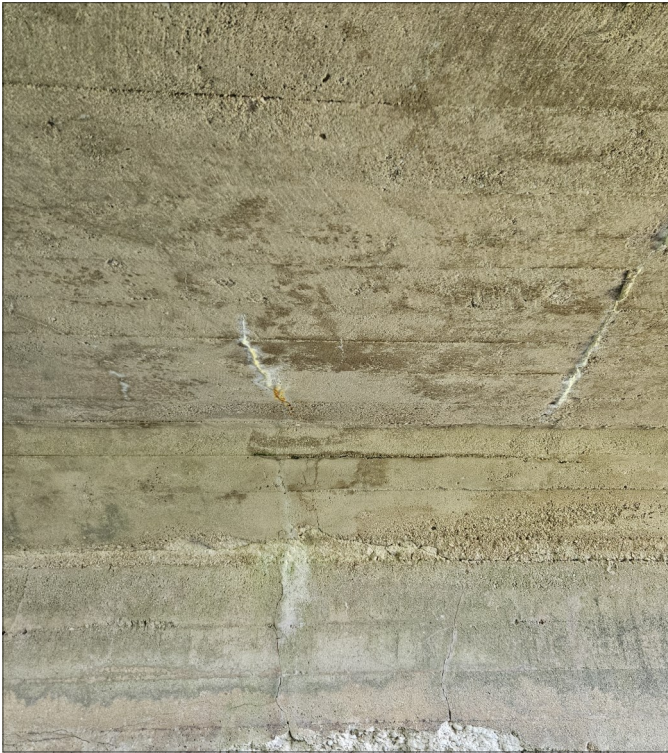
Photo 9 - View of Cracking in the Soffit and Abutment Wall.

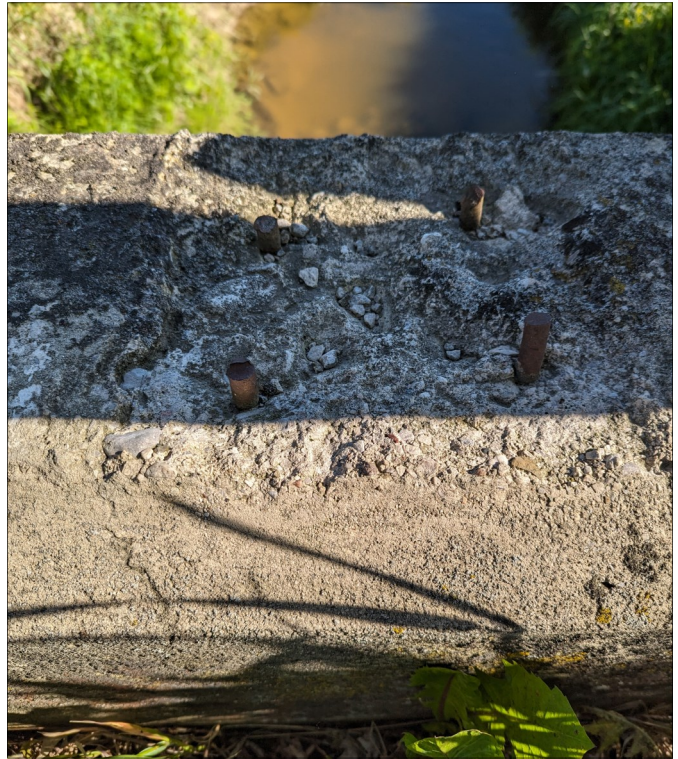
Photo 10 - View of Spalling at Previous Post Locations (typ.).

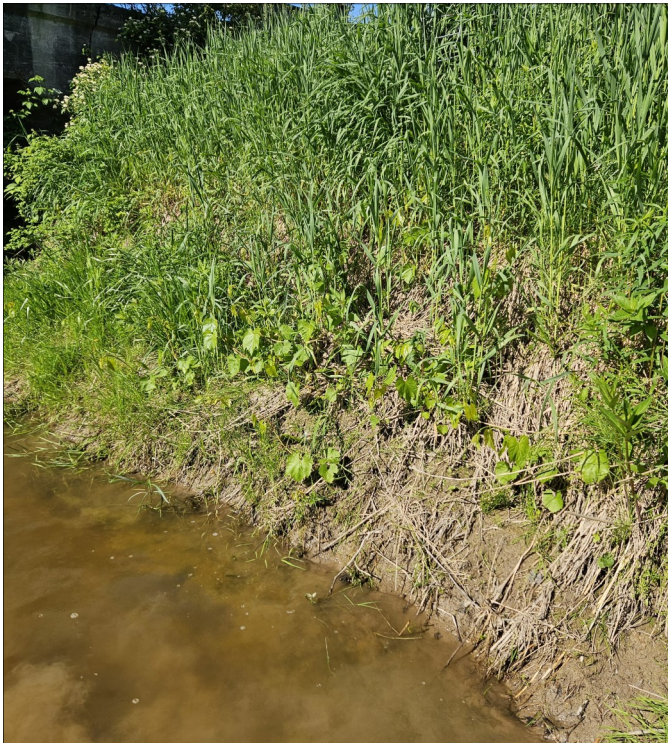
Photo 11 - View of Steep Embankments.

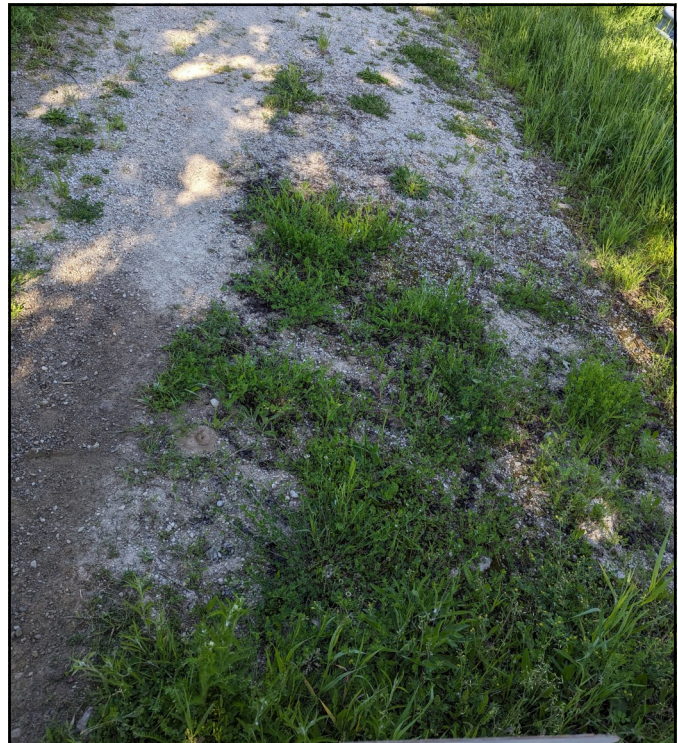
Photo 12 - View of Wearing Surface.
